# ENGINEERING TIMES

## HOUSE RAISING IN YARDLEY BOROUGH

### Recent Floods Create Unique Opportunities.

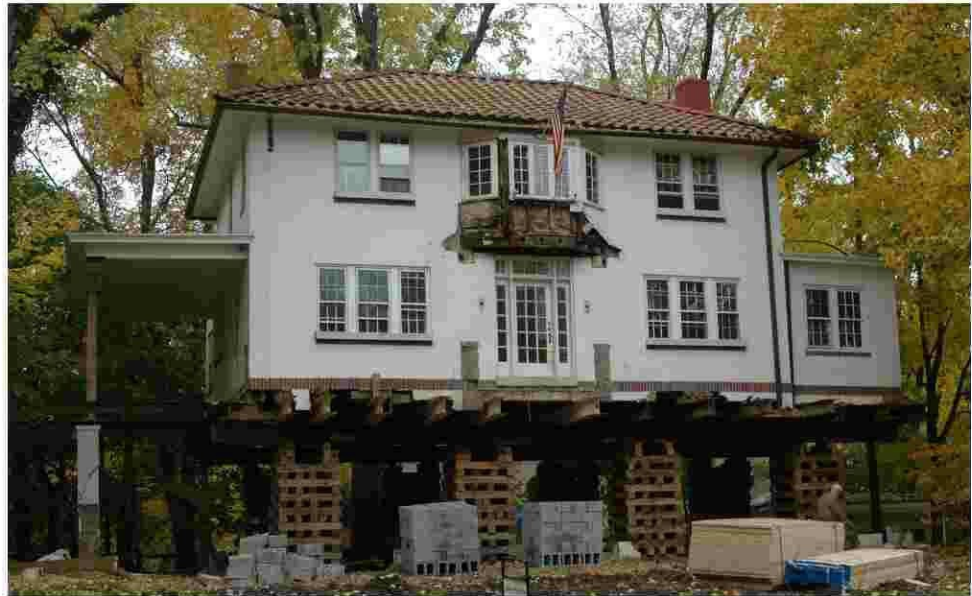
During the past several years, the Delaware River has flooded with increased frequency and caused damage to many homes along its banks, particularly in Yardley, PA. As a result, many homeowners in this area have sought the services of home lifting companies. Structural engineering services are also required for the design of the new bearing walls and frames, which will ultimately be in place to support the home in its final raised position.

Dumack Engineering had the opportunity to perform services recently in Yardley Borough. The first project was a two-story wood framed home. The building originally had a basement that consisted of stone foundation walls. The building was raised about five and a half

feet. After the home was raised, the basement was filled in with stone, and a new concrete slab was placed on top. A concrete cap was poured on the top of the existing stone foundation walls, providing a base that the new concrete masonry block walls could be constructed upon. Existing columns that were located in the basement were removed and relocated to new positions with foundations constructed for each. Columns were designed to support the deck in its elevated position.

The second project was also a two-story house with a basement, which was raised ten feet. All the exterior walls of the original home consisted of eight-inch thick brick. The home was raised and supported with new ten-inch thick concrete masonry block walls.

The basement was also filled in with a new concrete slab. In the front of the home, five large arches were created using steel beams and masonry columns. Clearance restraints around the elements used to lift the home made it necessary to give special consideration to the construction of these arches. A sequencing procedure was created to aid the contractor in the construction of this frame. In addition, steel beams were used to reframe the floor and distribute the load to the exterior walls, creating a more open space at the first floor. A deck was added, and the front entrance was transformed into a cantilevered balcony with a new canopy above.
